Manhole Inspection Summary

Manhole # S51GG_018MH

Insp Date: **3/5/10 2:05 PM**

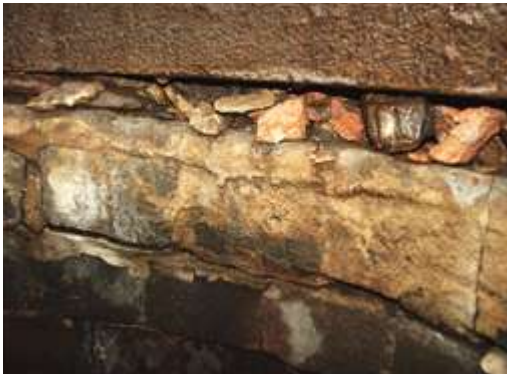
Defect 4

loose bricks

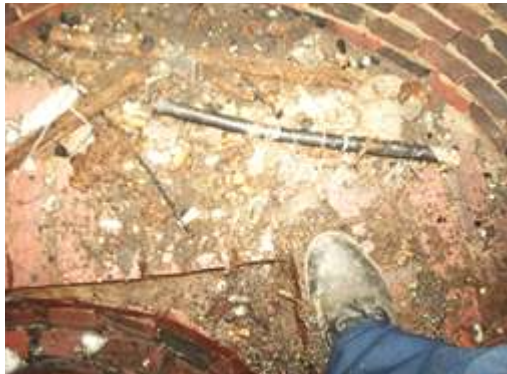
Defect 3

debris

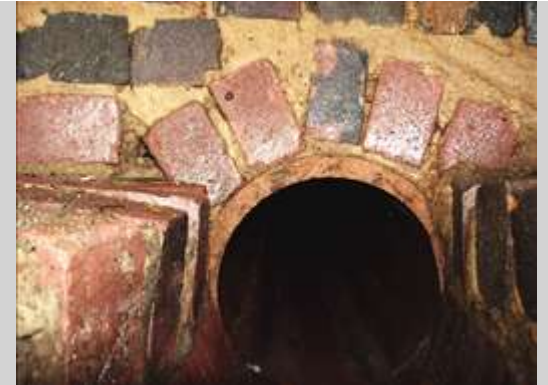
12 O'Clock Outflow

8 in. Circular Gravity Sewer
Pipe Out @ 12 O'Clock

Pipe Height: **12** (in.) Rod and Bar (Angled)
Pipe Material: **Clay** ☐ Pipe Lined
Invert Depth: **7.25** (ft.) Flow Characteristics: **Slow**
Deposits: ☒ None ☐ Mud ☐ Sludge ☐ Debris ☐ Grease
Silt Depth: (in.) Deposits Extent:
Infiltration: **None** Pipe Seal Cond: **Sound**

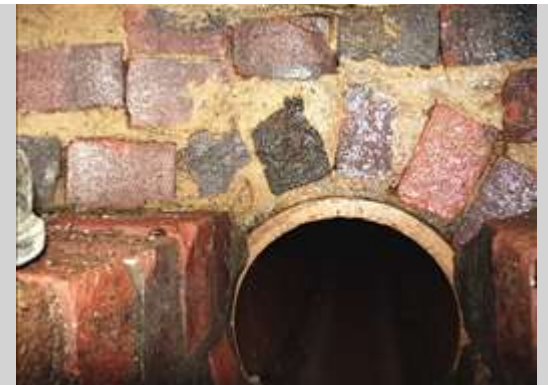
9 O'Clock Inflow

8 in. Circular Gravity Sewer
Pipe In @ 9 O'Clock

Pipe Height: **12** (in.) Rod and Bar (Angled)
Pipe Material: **Clay** ☐ Pipe Lined
Invert Depth: **7.17** (ft.) Flow Characteristics: **Slow**
Deposits: ☒ None ☐ Mud ☐ Sludge ☐ Debris ☐ Grease
Silt Depth: (in.) Deposits Extent:
Infiltration: **None** Pipe Seal Cond: **Sound**
